Texas Co-op Shifts to Condition-Based VM

By leveraging technology, PEC can keep up with long vegetation management cycles, customer growth and budgetary constraints.

By **GEORGE LEADER** and **PENNY SWANNER**, Pedernales Electric Cooperative

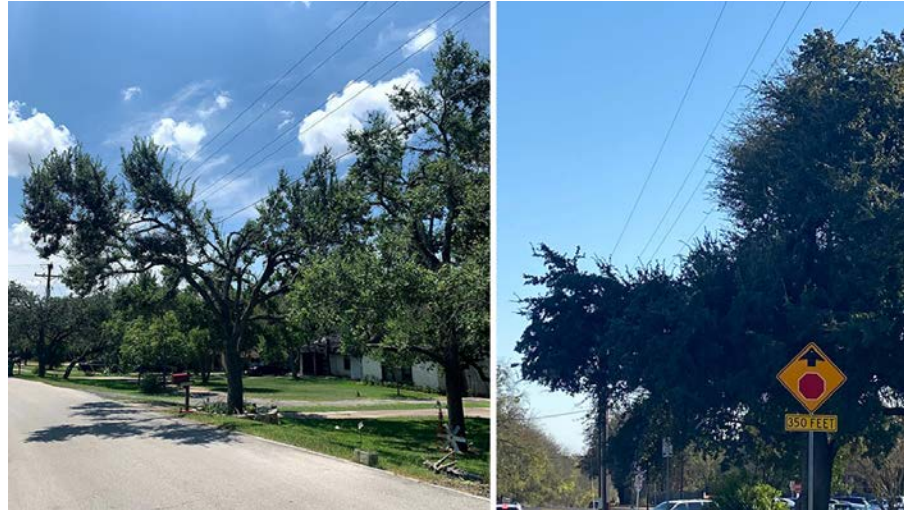
These examples of V-Cut (left) and L-Cut (right) directional pruning create challenges for accurate satellite-based encroachment detection.

Additionally, satellite data tended to struggle with certain types of directional pruning such as “V” cuts or “L” cuts, when trees were under the lines and existing acceptable clearance was indistinguishable, making the accuracy somewhere between 70-80%. The same condition would be even more true with overhang scenarios.

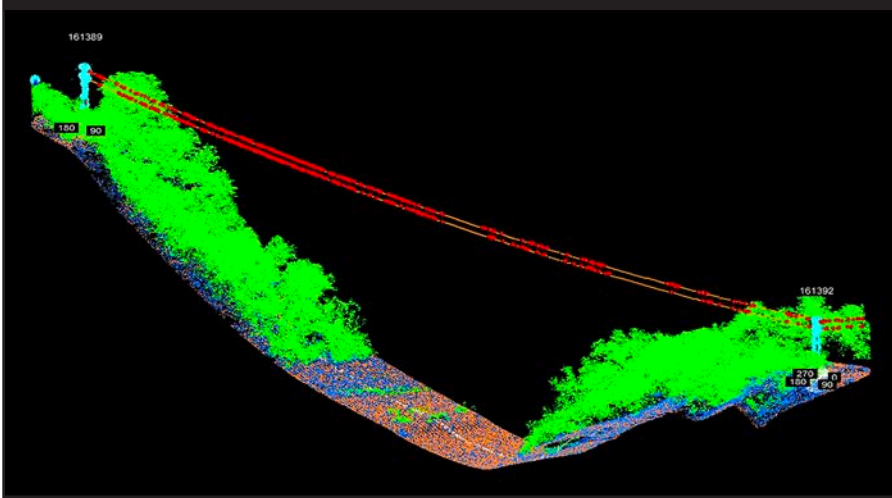
A 3D Geiger-mode LiDAR supports PEC's water crossing analysis.

PEC’s investment is already paying off in other business areas. For instance, PEC used the data to calculate the height of certain voltages of conductors above specified bodies of water. Another use case recently completed was for “Last Mile Fiber” allowing the Transmission Control Center to identify specifications on towers fit for hosting fiber and ensure NESC clearances are met without having to deploy personnel to the field.

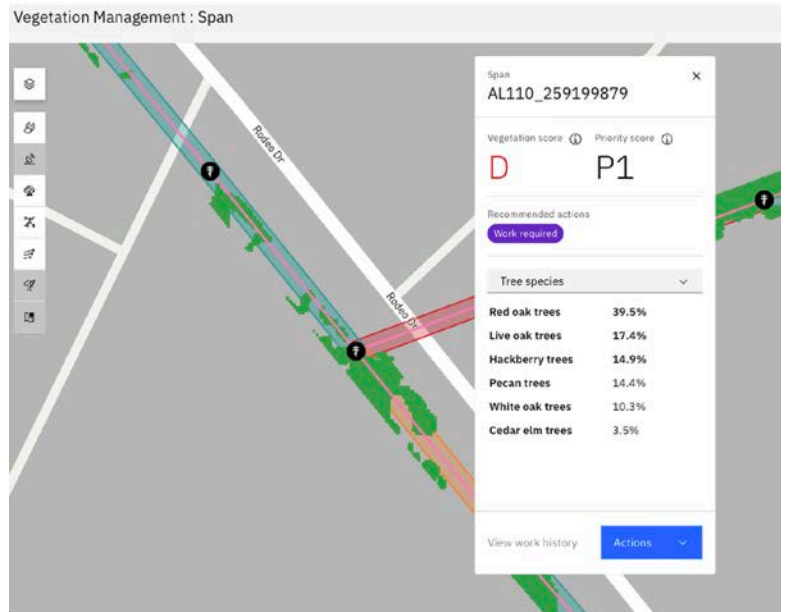
Span level identification of critical tree species, expressed as a percent occupancy of the span.
